**LAKE GARDA**  
**DREDGE STUDY AND INVESTIGATION**  
**PREPARED FOR**  
**LAKE GARDA IMPROVEMENT ASSOCIATION**  
**BURLINGTON & FARMINGTON, CT**

**PREPARED BY**  
**MACCHI ENGINEERS, LLC**  
**44 GILLET ST**  
**HARTFORD, CT**

JANUARY 2012

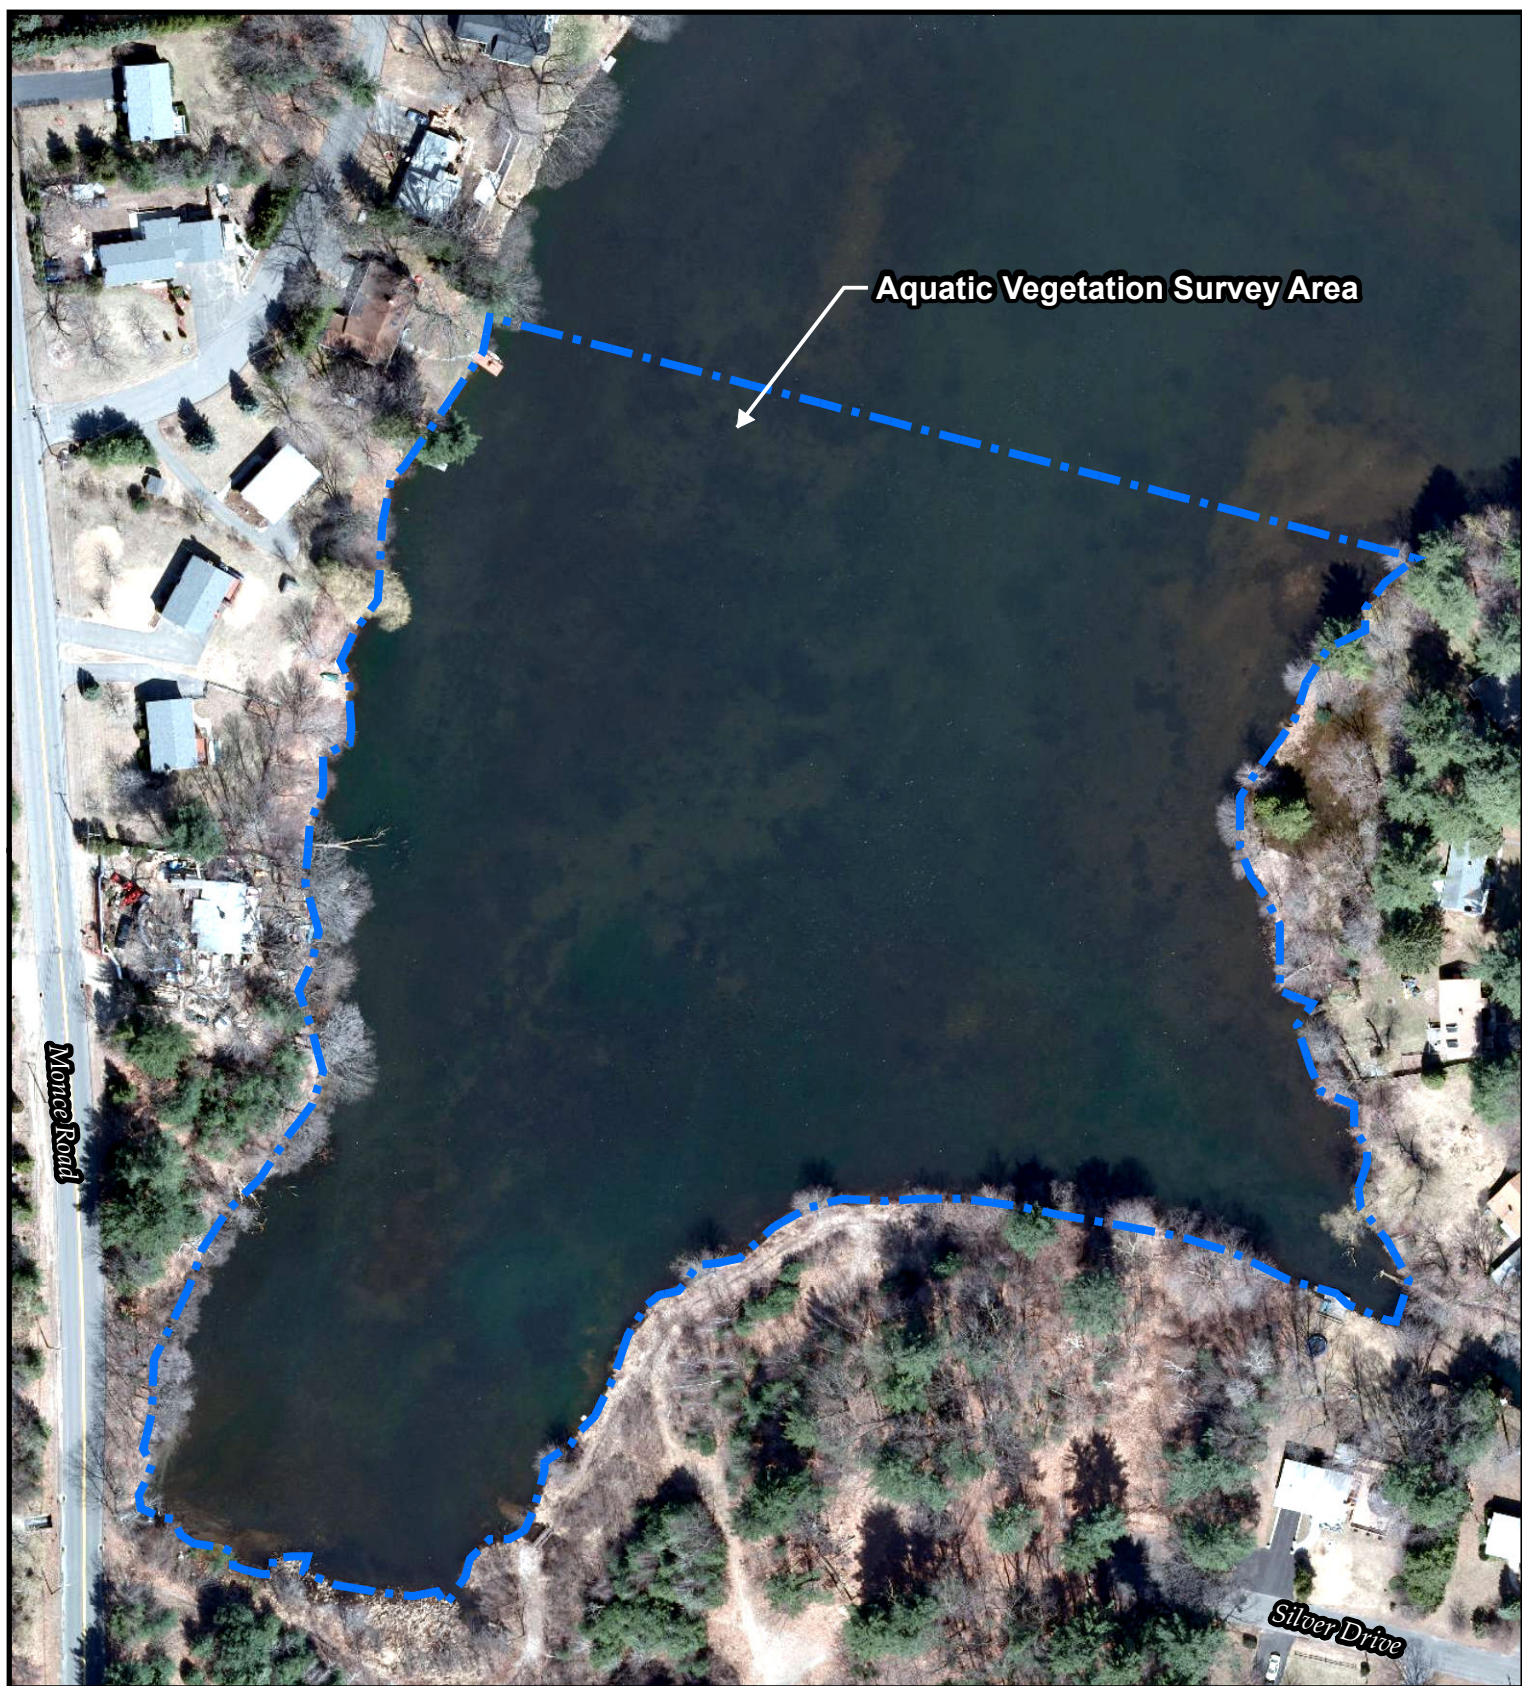
**FIGURE 4**  
**Aquatic Vegetation Survey Area**  
**Lake Garda**  
**Burlington, CT**

Aerial photograph (2009) showing the area of aquatic vegetation surveys (in blue) conducted by an EPS botanist in November 2011.

An aquatic vegetation survey (in the study area shown on Figure 4) was conducted by EPS botanist James Cowen on November 8, 2011. Aquatic vegetation was dormant and had partially died back. Conditions were sunny and 60 degrees F. Plant identification was limited to persistent vegetation. Since plants were dormant the maximum extent of coverage during the growing season could not be fully determined. Based on observation by kayak and analysis

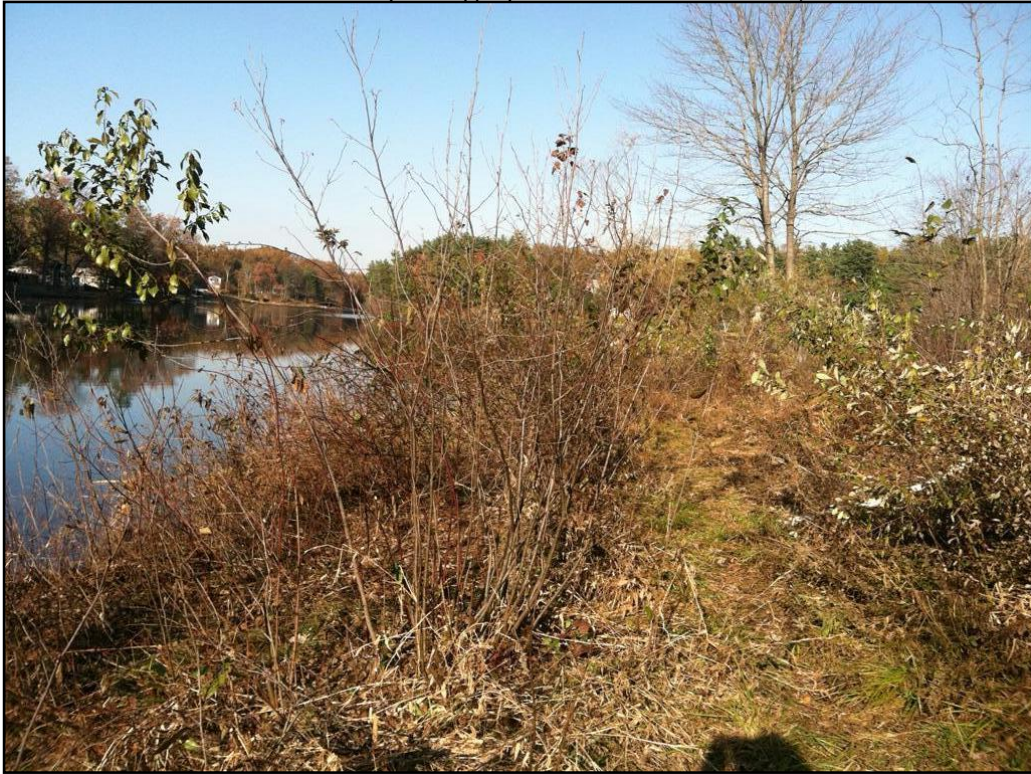
Photo 7: Wetland 4 looking east

**Wetland 4** is shrub-scrub pond shore with patches of emergent marsh. The open shrub scrub layer consists mostly of Speckled Alder, Glossy Buckthorn\* (*Frangula alnus*), Red Maple, Weeping Willow (*Salix babylonica*), Silky Dogwood, Pussy Willow (*Salix discolor*), Japanese Barberry\* (*Berberis thunbergii*), and Multiflora Rose\*. The herb layer is composed mainly of grasses, including Japanese Stiltgrass\* (*Microstegium vimineum*), sedges, Softstem Bulrush, Rough-stemmed Goldenrod, Grass-leaved Goldenrod (*Euthamia graminifolia*), Swamp Dewberry (*Rubus hispida*), Cinnamon Fern (*Osmunda cinnamomea*), Purple Loosestrife\* (*Lythrum salicaria*), burreed (*Sparganium sp.*), and Poison Ivy (*Toxicodendron radicans*). The vine layer is Fox Grape (*Vitis labrusca*).
